CORRELATION OF SITE CONDITION - BUILDINGS DAMAGES – AND GROUND RUPTURE OF THE 27 MAY 2006 YOGYAKARTA EARTHQUAKE – CENTER JAVA AND MICROZONATION OF THE AREA DAMAGE

Engkon K. Kertapati, Marjiyono

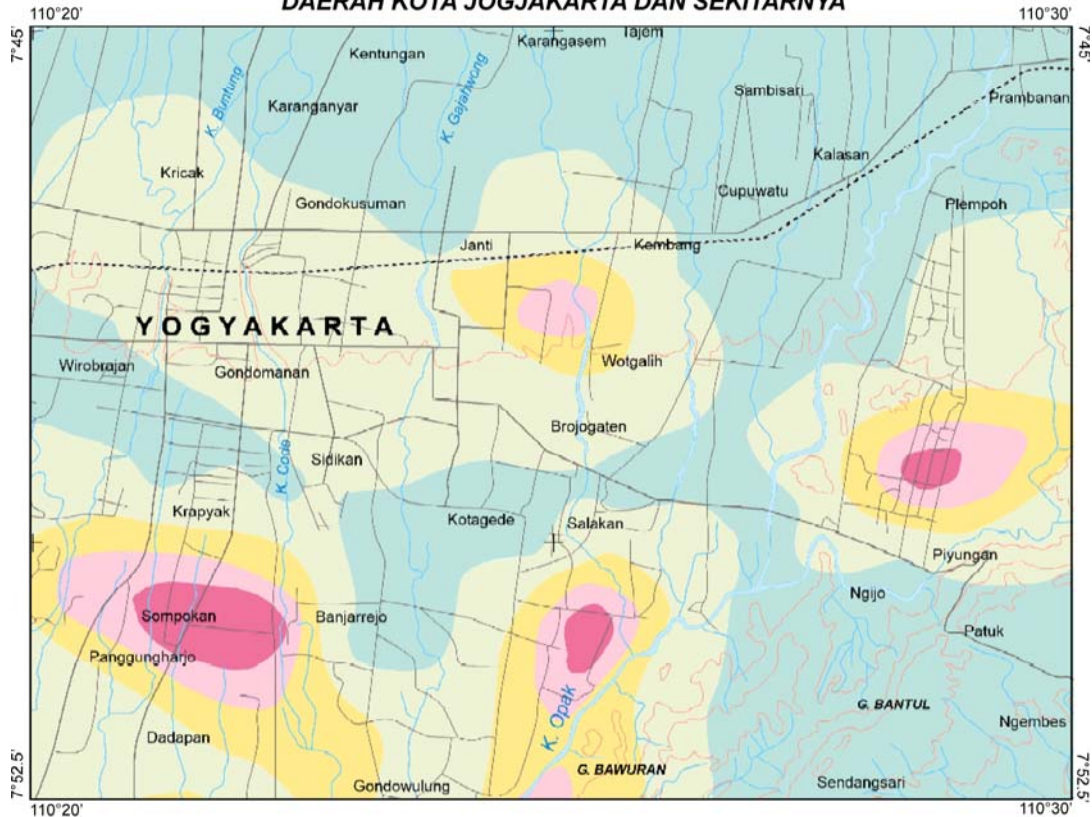
Figure 4 Microzonation of the Yogyakarta Damage area on the basis of variation of the predominant period

The microtremor measurements show that the sites with severe damage located near and along the river banks have a considerably long predominant period more than 0.4 s. This matches quite well with the variation of damage distribution (Figure above), which suggest that the thickness of sand, sandy sand and clay in those area are deep. The predominant period decreases towards the north and southeast and the period reduces to below 0.2 s.

According to the variation of the predominant period of the ground, the Yogyakarta damage area due to Yogyakarta earthquake 2006 is classified into five zones as follows:

- (a) Zone I - period less than 0.1 s
- (b) Zone II - period ranging from 0.1 s – 0.2 s
- (c) Zone III – period ranging from 0.2 s – 0.3 s
- (d) Zone IV – period ranging from 0.3 s – 0.4 s
- (e) Zone V – period more than 0.4 s

areas along the river bank or near the beach. This could cause severe damage to the long period structures such as high-rise buildings. Hence, special attention should be given towards the seismically resistant design of such structures.
