CORRELATION OF SITE CONDITION - BUILDINGS DAMAGES – AND GROUND RUPTURE OF THE 27 MAY 2006 YOGYAKARTA EARTHQUAKE – CENTER JAVA AND MICROZONATION OF THE AREA DAMAGE

Engkon K. Kertapati, Marjiyono

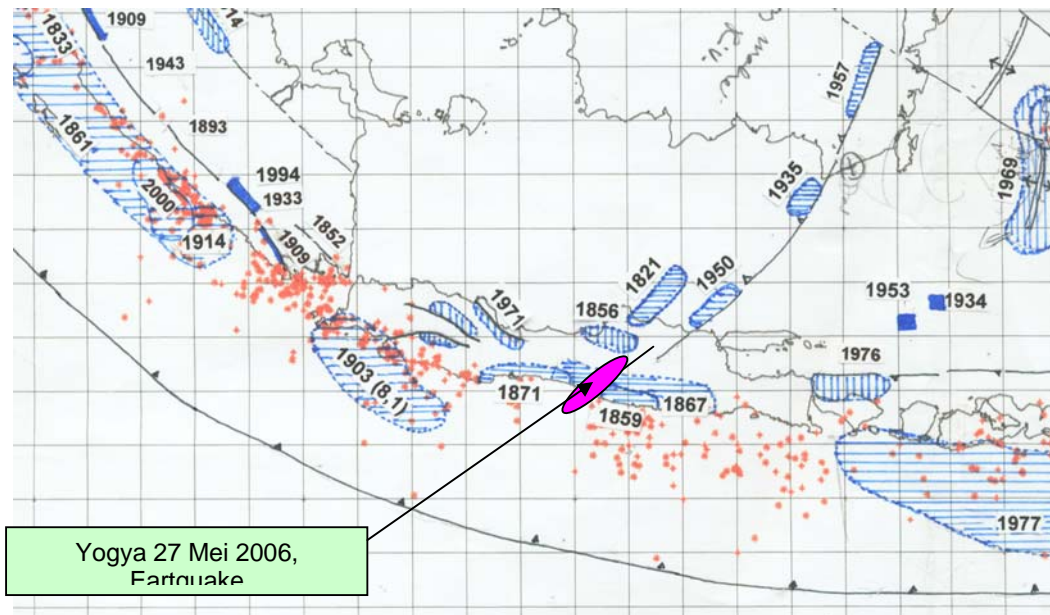
Figure 1 Historic of significant damage earthquakes around Java and vicinity area

We summarize that historic earthquake events were caused by the movement of the Melange Cretaceous-Tertiary Fault (Figure 1). Wichmann (1918) reported those earthquakes occurred in entire of Java correlated to the fault activities (Figure 2)
